Docket No. 217 – Development and Management Plan Inspection

Date: May 13, 2005

Location: Norwalk Substation Expansion

Location: Plumtree Substation Expansion , Bethel

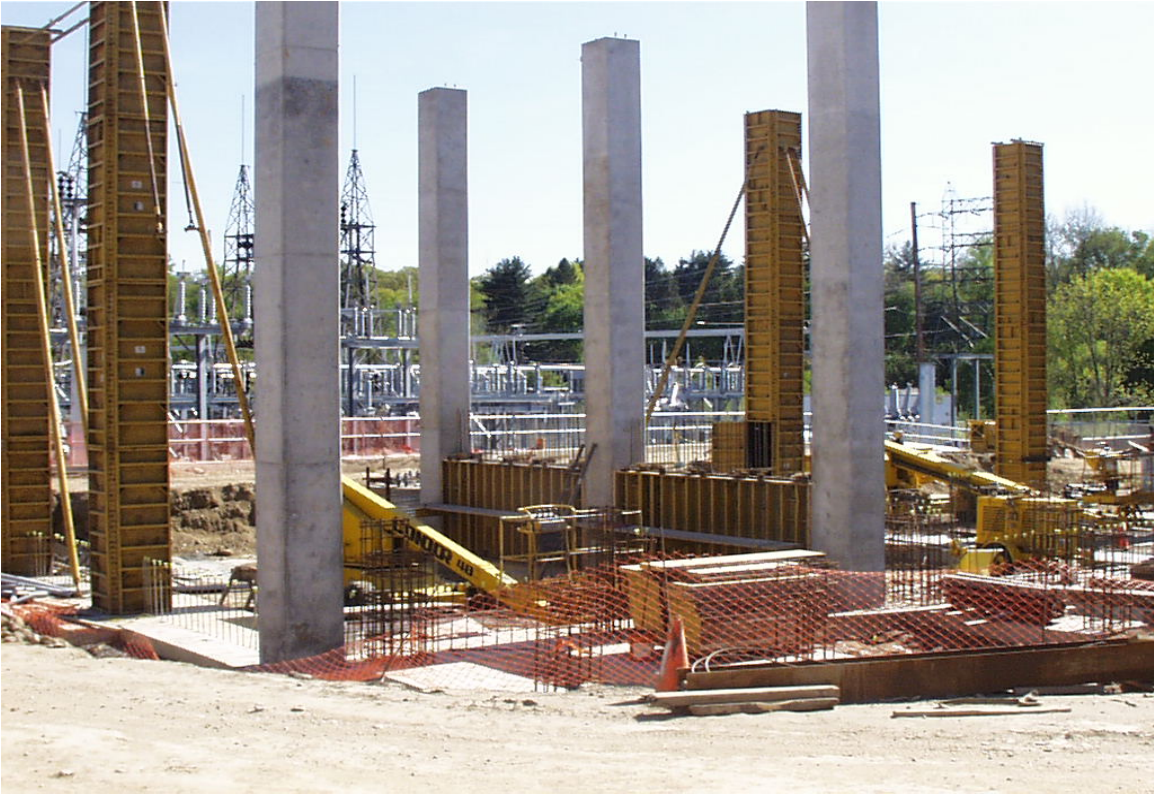
Norwalk Substation-Structure work continues on structures near the GIS building. (5/13/05)

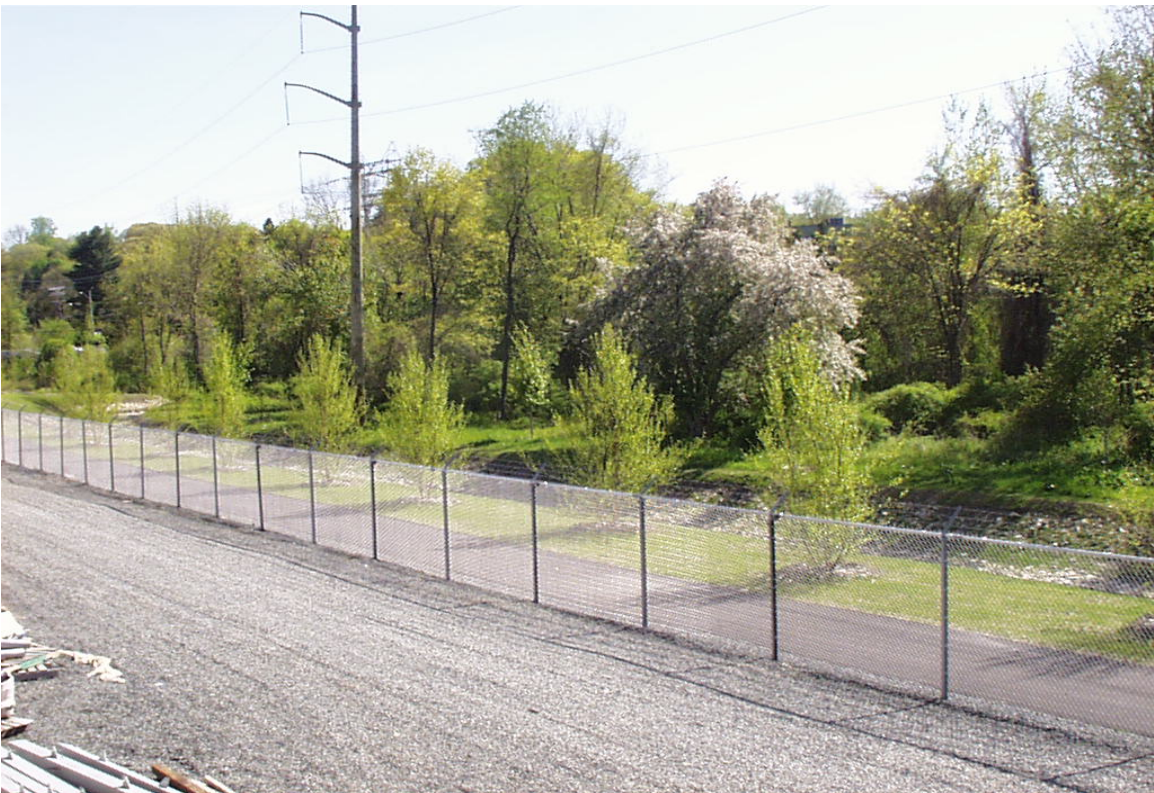
Areas of Inspection	Observation	Recommended Action
Erosion and Sediment Controls (includes inspection within 24 hours of a storm event)	-The overflow channel continues to work well with some minor erosion along the slope and grass growth is noticeable along the sides. The plantings within the channel are also showing good growth 4/27-5/13/05.	- Continue to monitor for overall stabilization. Vegetative growth appears to be off to a good start and the situation should be evaluated later in the growing season. The minor erosion may require repair if it worsens. 5/13/05

Overflow channel along the Norwalk River with plantings leafing out. (5/13/05)

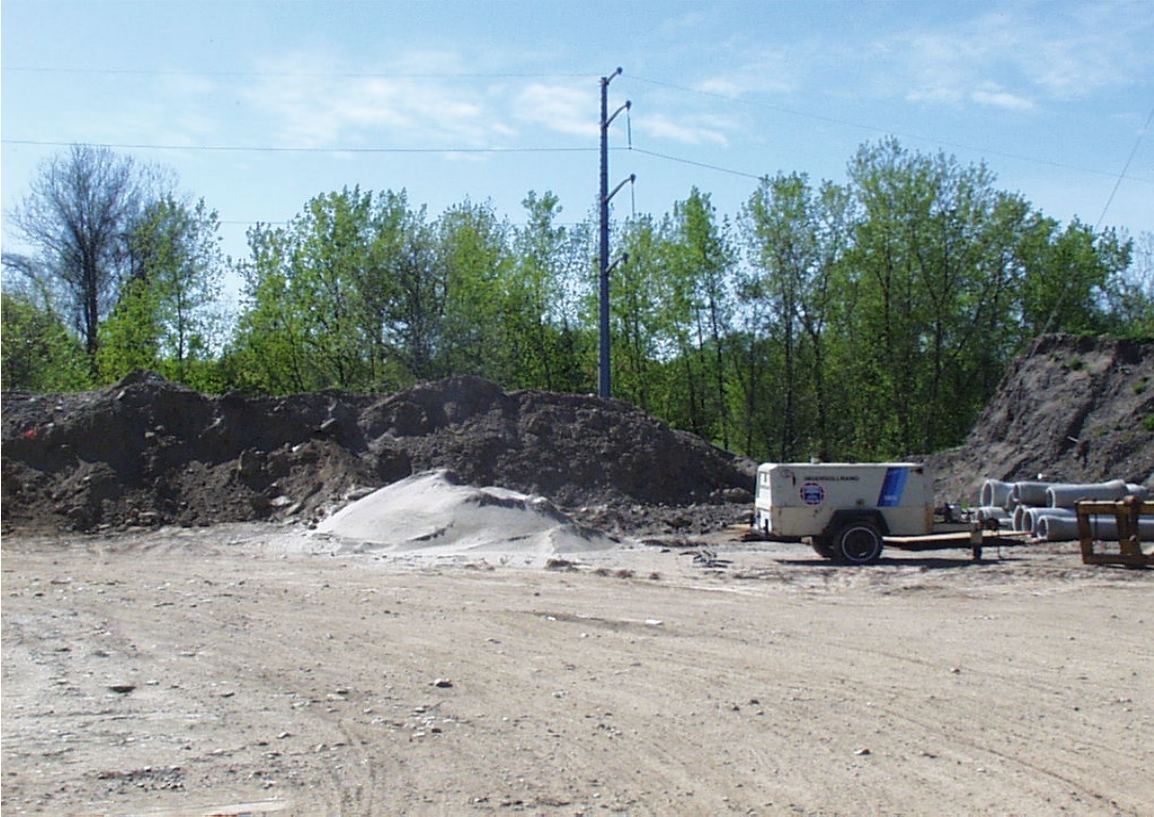
- Soil stockpiles that remain on site will be used as backfill or topsoil. 5/13/05	- All stockpiles and excavation areas are well within the site and there are no issues at this time. 5/13/05
Inland Wetland and Watercourse encroachment and mitigation	- Silt fence has been removed from most areas along the wetland/river side of the channel as the area is stabilized. 12/16/04	-None at this time. Continue to monitor.
State species of concern, threatened and endangered species	- No species of concern are located in this area of construction.	- N/A
Vegetative clearing limits (including trees to save or danger trees noted)	-Many of the tree plantings are leafing out and appear to be doing well. Grass is growing in along the sides of the channel and herbaceous plantings in the channel are showing growth 04/27-5/13/05	- A survey should be performed to see whether any of the plantings did not survive the winter for replacement purposes but this does not seem to be a problem. 5/13/04

View of the remaining soil stockpiles. Soil that is left will be used as backfill and topsoil on site. (5/13/05)

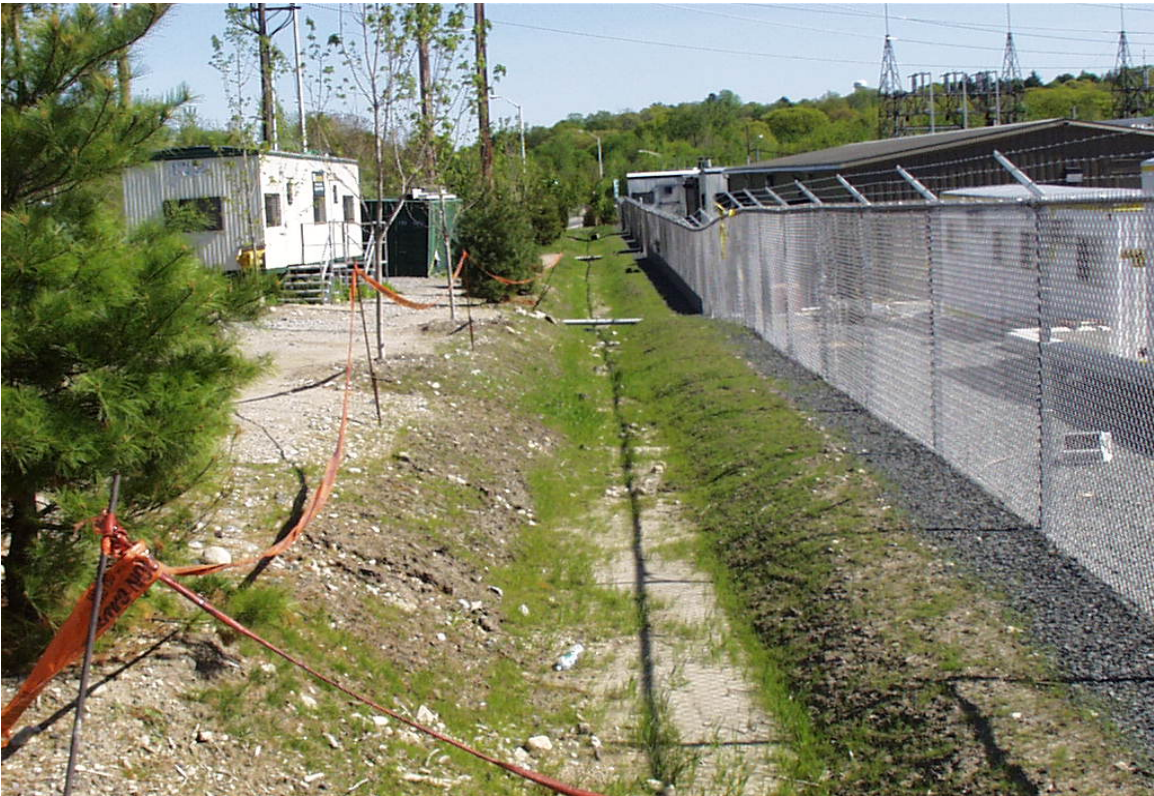
View of the perimeter ditch with some vegetative growth. (5/13/05)

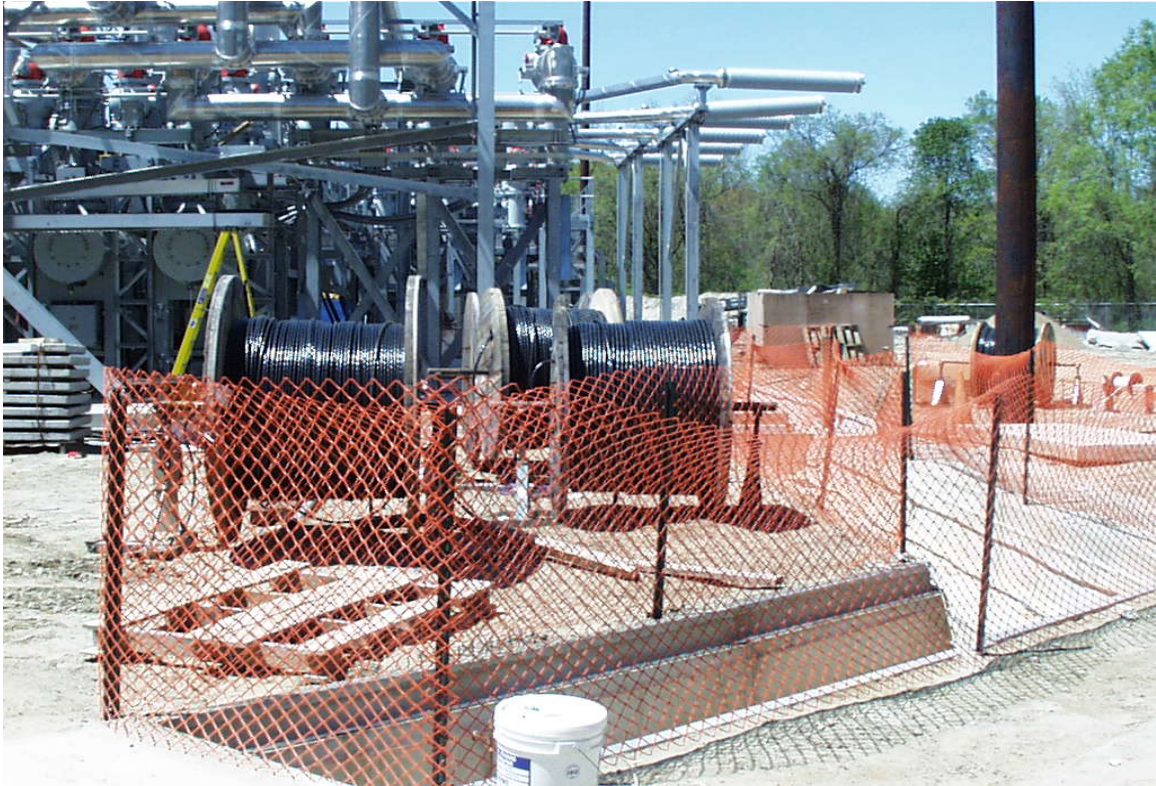
Plumtree Substation: Work is ongoing pulling cable through the existing trenches. (5/13/05)

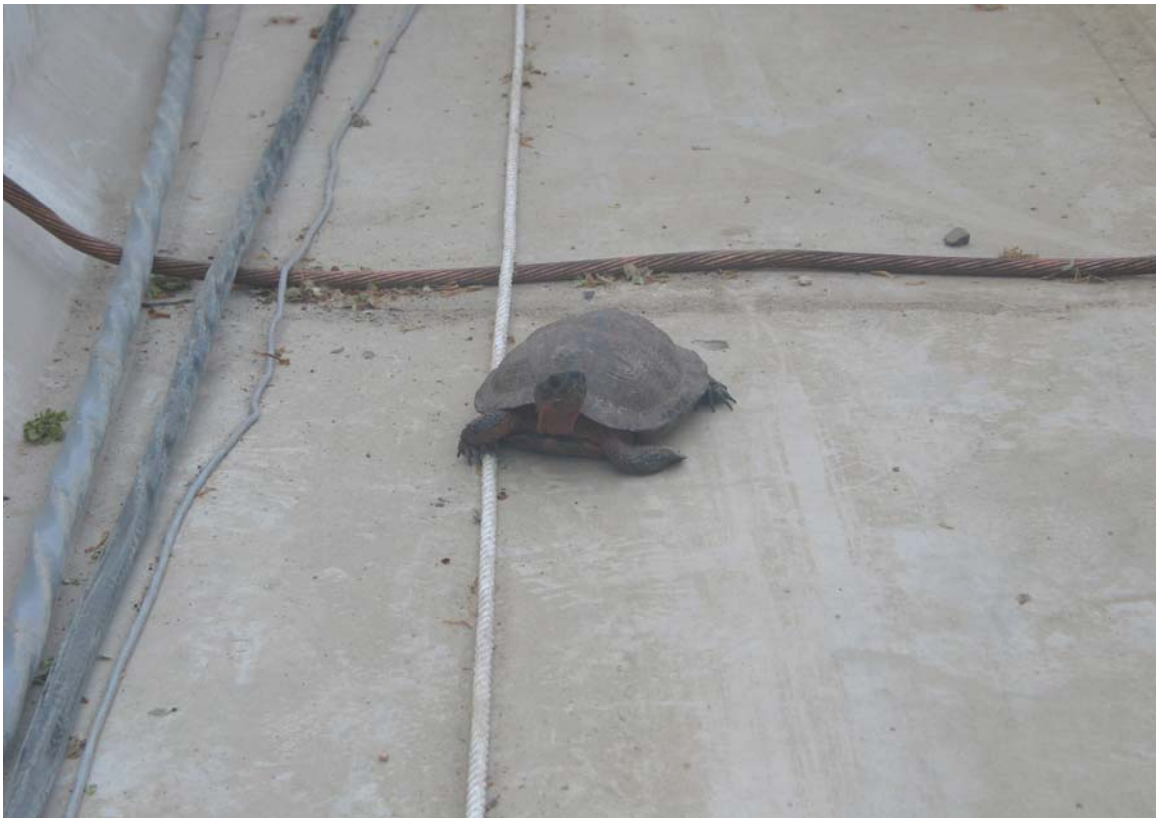
A wood turtle (CT species of special concern) noted walking through the substation on 5/12/05. The turtle was placed outside of the substation in the adjacent wetlands.

Areas of Inspection	Observation	Recommended Action
	- A majority of the soil has been removed to appropriate off-site locations but some will remain on an as needed basis for the remainder of construction. Portions are not covered in plastic but are well within the site. 3/2-5/13/05	-Continue to monitor status and cover stockpiles with plastic if necessary. 3/2-5/13/05
Inland Wetland and Watercourse encroachment and mitigation	- Wetlands are located around the outskirts of the substation yard. The work within the substation yard has caused no observed sedimentation. 5/13/05	- The stone berm around the perimeter of the yard continues to prevent sedimentation and water from leaving the site and getting to the wetland edge. 5/13/05
State species of concern, threatened and endangered species	- Although the diversity database indicates no state listed species are in this area, a wood turtle (a species of special concern) was observed walking through the substation on 5/12/05. It was placed outside of the perimeter fence by hand in the adjacent wetlands.	- Everyone at the substation will be told to move machinery carefully and to be more aware. If any signs of digging are observed, the area should be investigated for a nest. - Any holes in the base of the perimeter fence should be repaired to help keep the turtle out of the work area.
